Eagle Eye Inspection Services

CONFIDENTIAL INSPECTION REPORT

123 Sample Report Ave , Sample, CA 945

SUMMARY REPORT

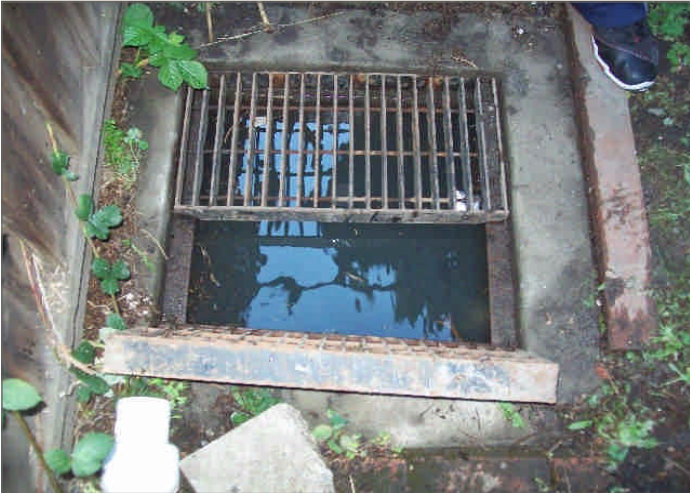
- q There is an accumulation of silt and debris in the catch basins that should be removed. This is indicative of poor maintenance, and if the silt and debris is left to accumulate and builds to the level of the drain lines, it could pass into them, harden during the summer months, impede drainage, and lead to blockages. Therefore, the drain lines should be flushed through to the street or to their termination point.
- q There is standing water or debris visible within the area drains, which is indicative of at least a partial blockage. The tendrils of roots may have invaded the drains, but silt also tends to become trapped within the drain pipes and hardens during the summer months to the consistency of wet concrete and creates an impediment that commonly leads to a full blockage. Therefore, we recommend that the lines be flushed

through to the street or to their termination point.

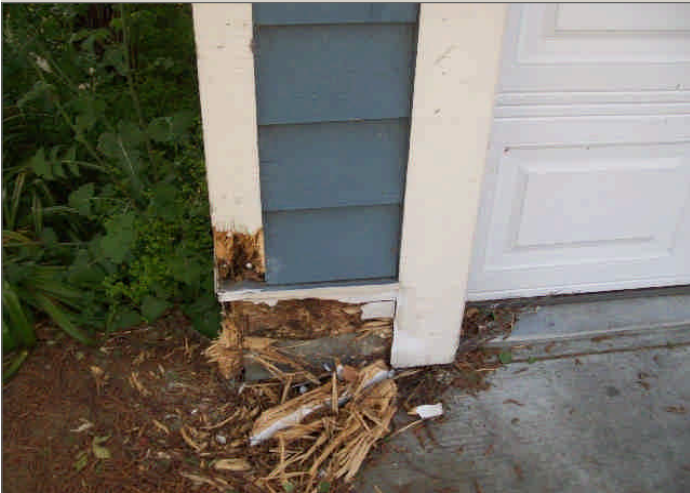
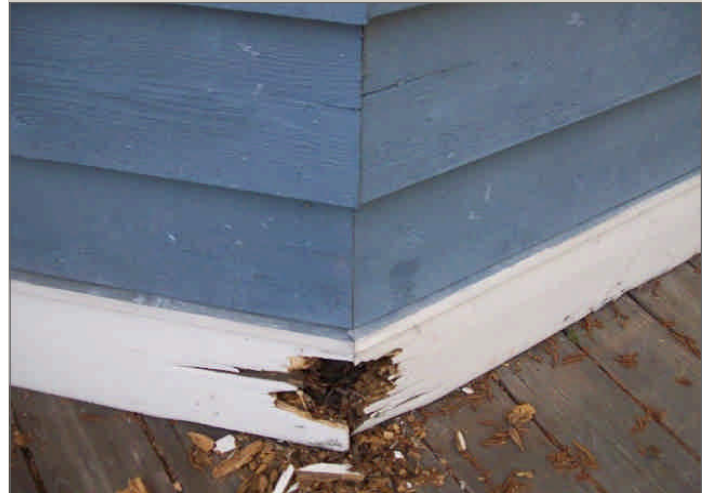
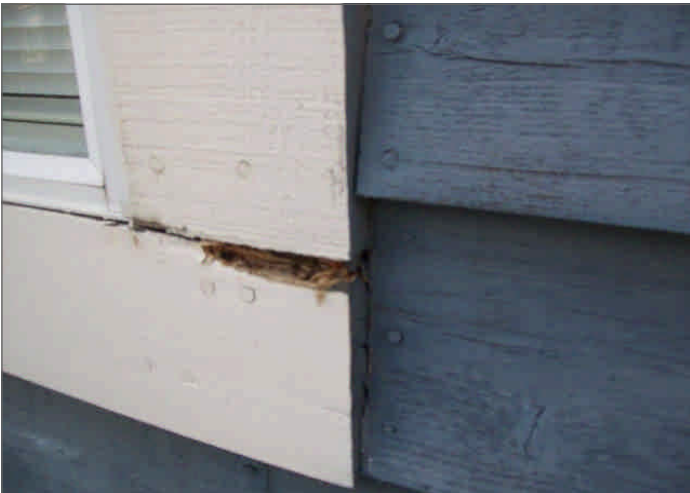
- q Sections of the fascia and trim need maintenance type service. Open joints need to be sealed through out the structures exterior to forestall water intrusion.
- q Sections of the fascia board or wood trim are weathered, and should be serviced to prevent further deterioration.
- q There is damage to the wood trim that should be evaluated by a termite inspector.

There is damage to the wood trim that should be evaluated by a termite inspector - *Continued*

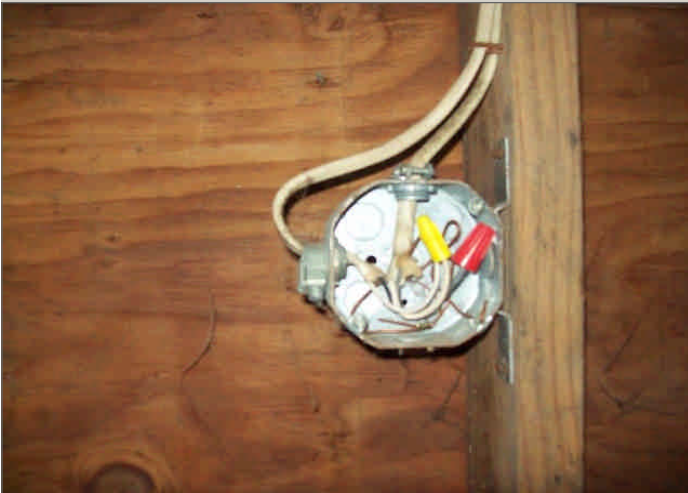
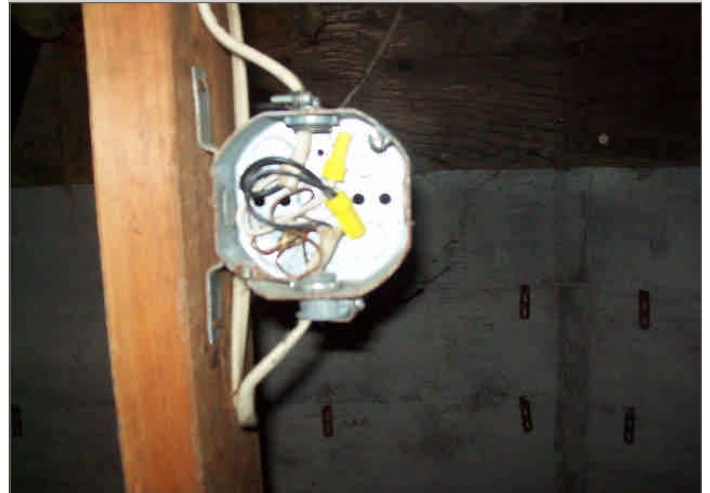
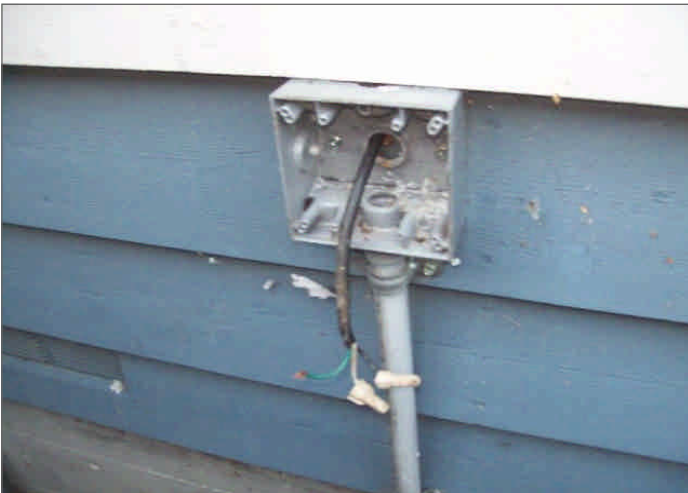
- v There are open electrical junction box, which should be sealed. This is evident under the house and at the side yard

There are open electrical junction box which should be sealed - *Continued*

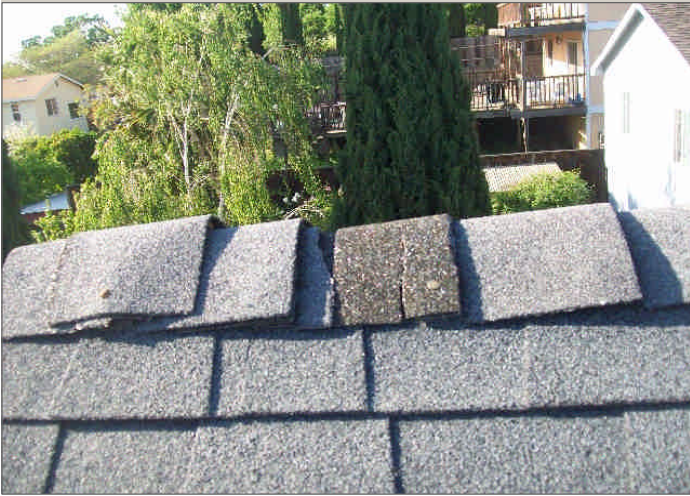
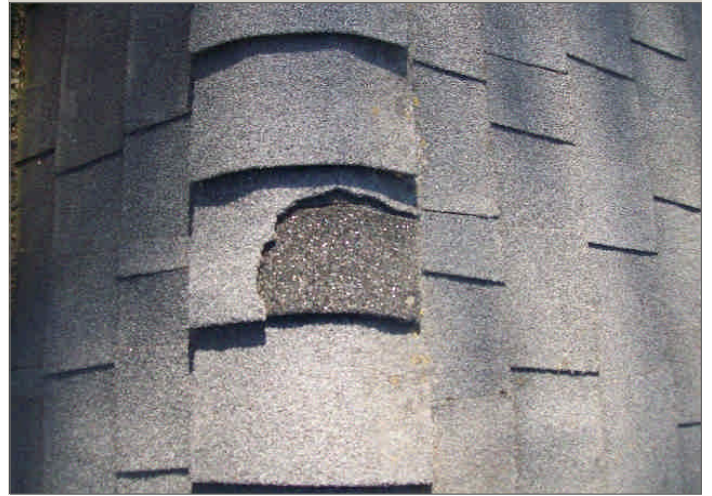
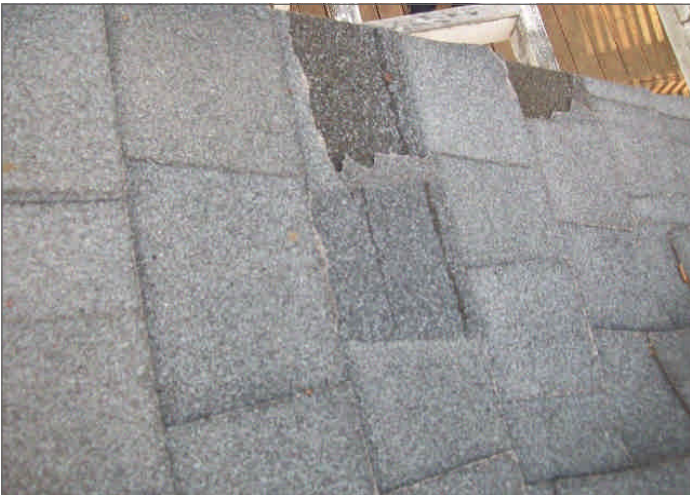
- q There are missing shingles and exposed underlayment and should be evaluated by a roofing contractor, because the cost of replacing the roof could significantly affect your evaluation of the property.
- q There are some missing shingles that need to be replaced

There are some missing shingles that need to be replaced - *Continued*

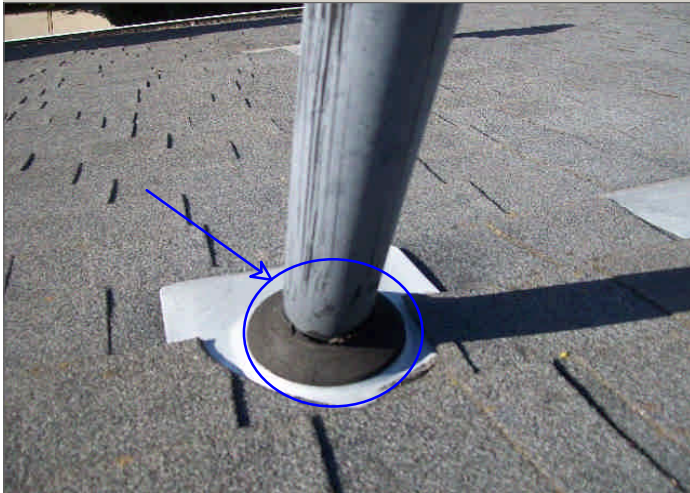
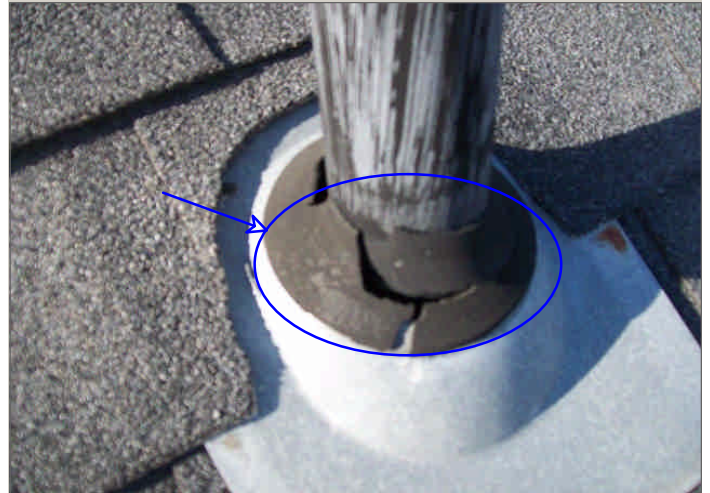
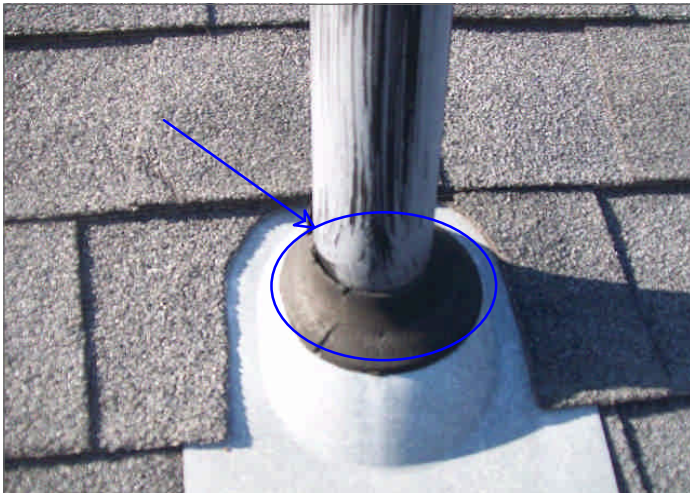
- q The roof flashing's need to be sealed or serviced. They are comprised of metal that seals valleys and vents and other roof penetrations, and are the most common point of leaks. This is particularly true of the flashing's on a layered roof, which are covered by the roofing material and which are even more susceptible to leaks. The rubber boots need to be replaced

The roof flashing's need to be sealed or serviced - *Continued*

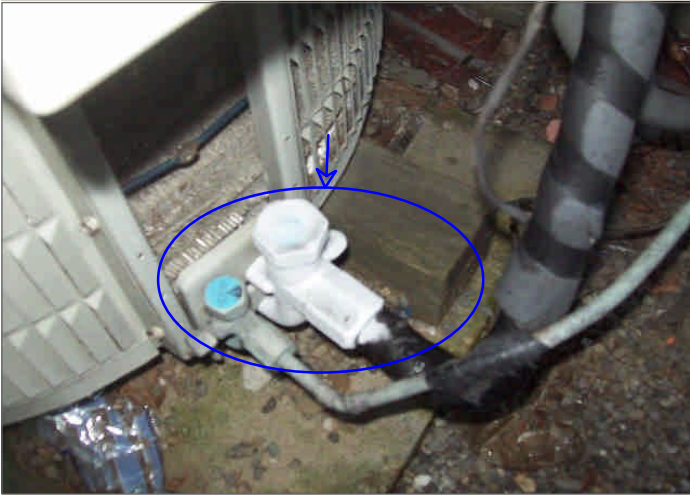
- q Ice forms on the refrigerant lines, which has multiple causes ranging from closed off registers and clogged filters to low refrigerant, and the system should be serviced by an HVAC contractor.

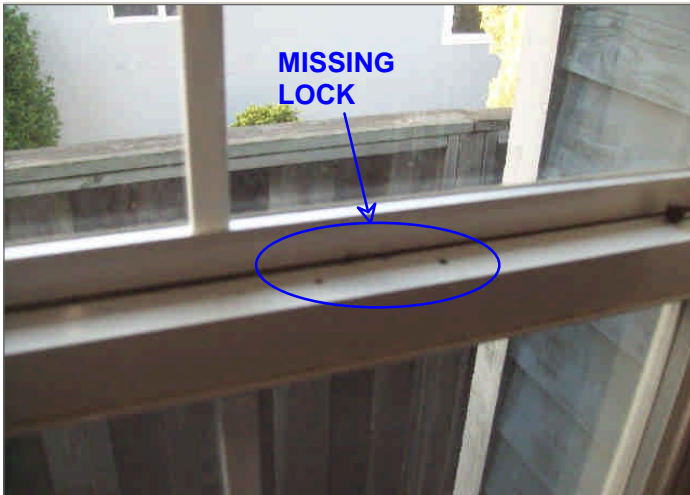
- q A windows lock is missing or does not engage, and should be serviced.

A window lock is missing or does not engage and should be serviced - *Continued*

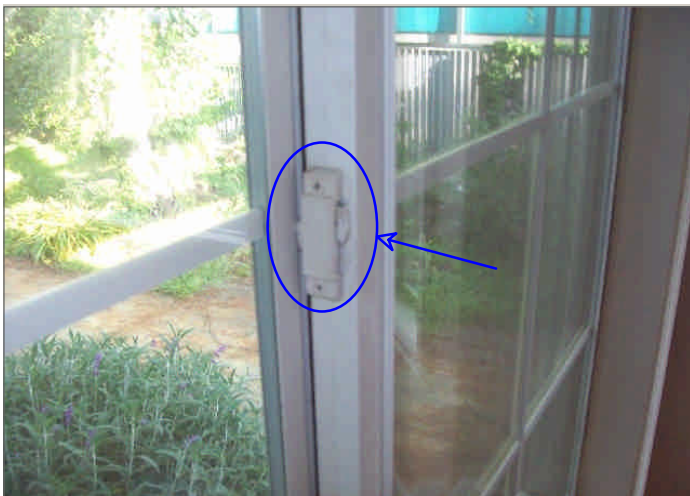
- q A windows lock is missing or does not engage, and should be serviced.

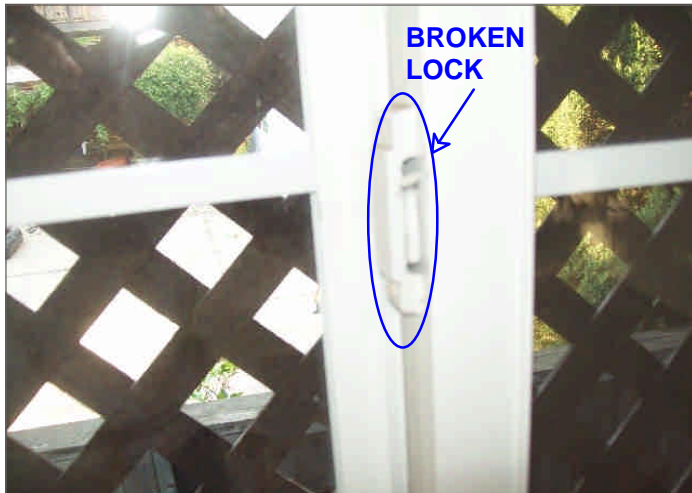
- q A window lock is missing, or needs to be serviced, to be functional.

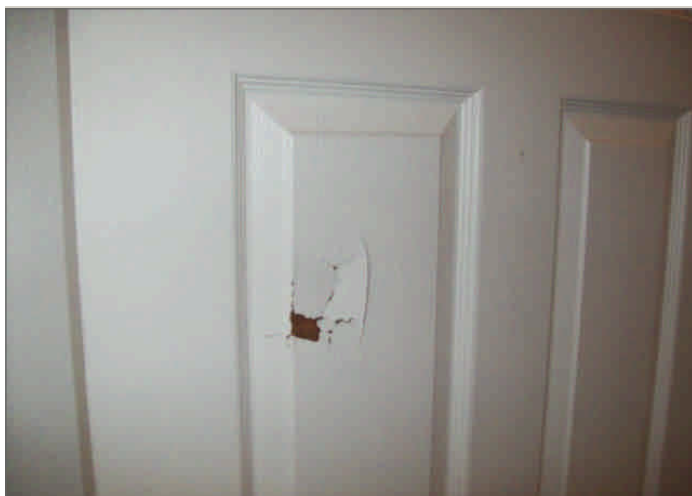
- q The door rubs, and needs to be serviced to work smoothly.
- q The door is damaged and should be repaired or replaced

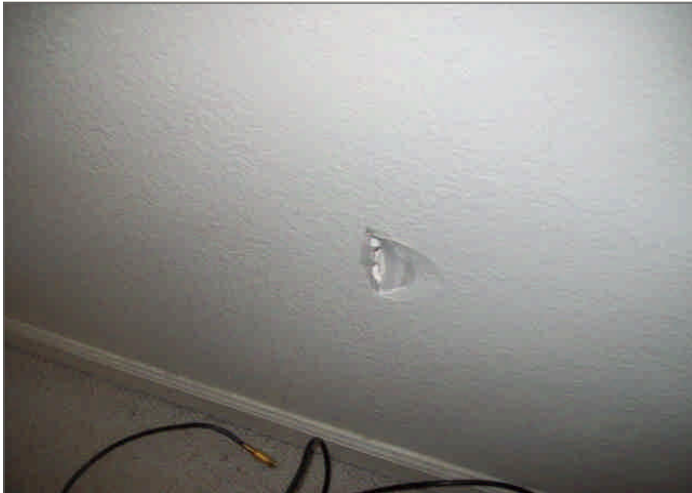
- q The walls have typical cosmetic damage.

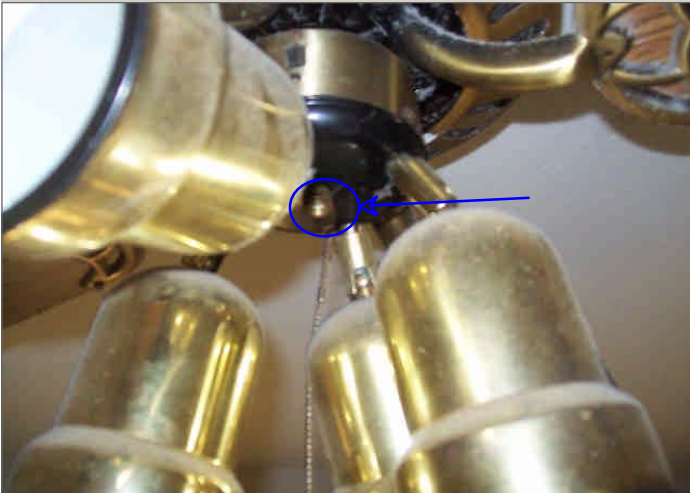
- q The pull chain for the light switch is missing

The pull chain for the light switch is missing - *Continued*

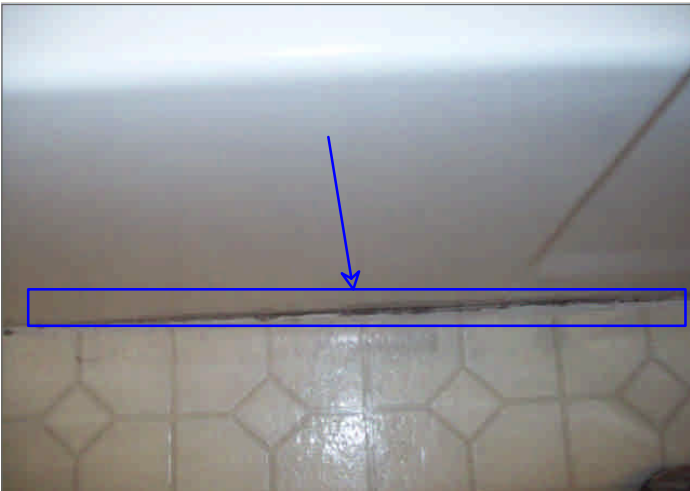
- q The floor seam next to the bath tub is lifting due to moisture penetration or poor workmanship. This should be sealed to forestall moisture damage

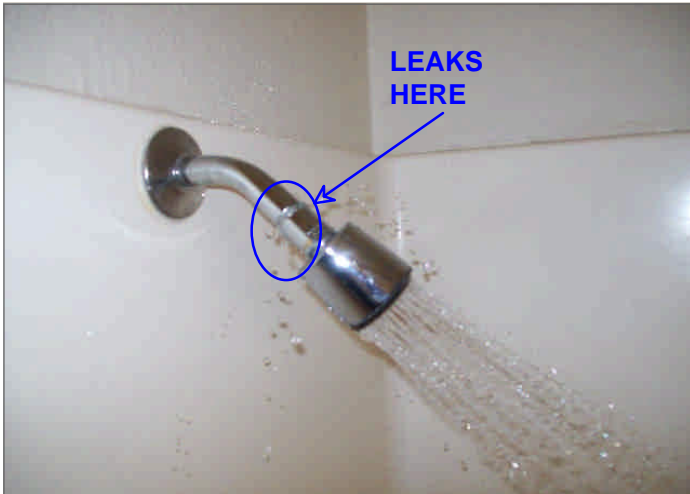
- q The tub-shower valves leaks

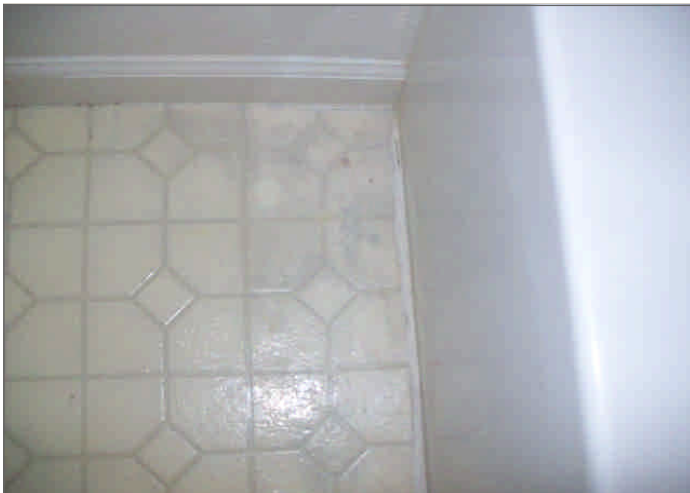
- q The floor is moisture damaged and should be evaluated by a termite inspector.

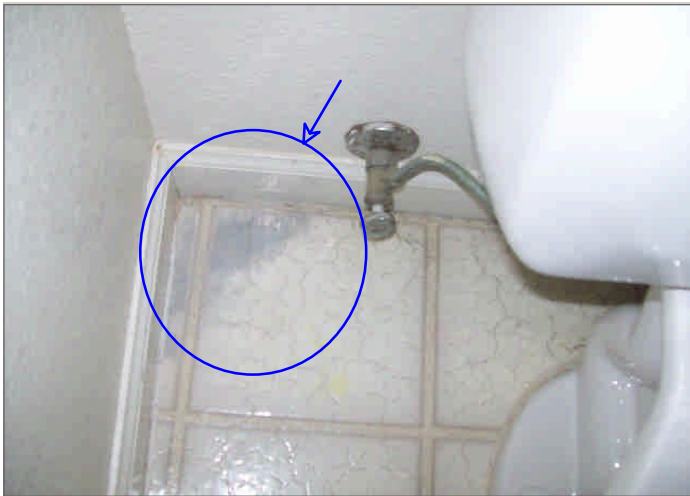
- q The floor is moisture damaged and should be evaluated by a termite inspector.

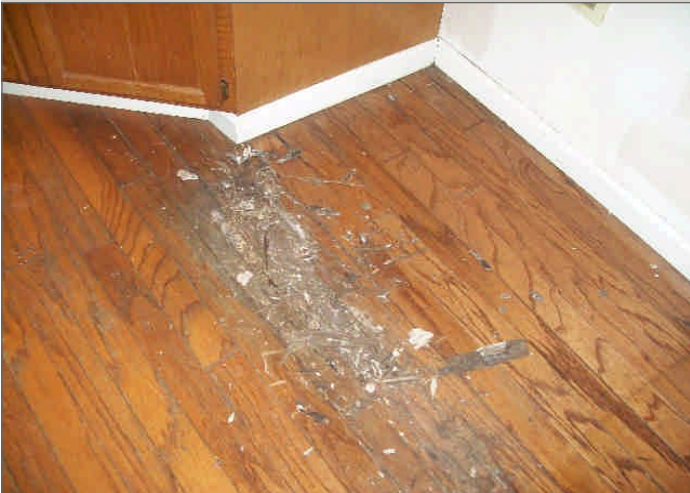
- q The floor is moisture damaged and should be evaluated by a termite inspector. In main house

The floor is moisture damaged and should be evaluated by a termite inspector - *Continued*

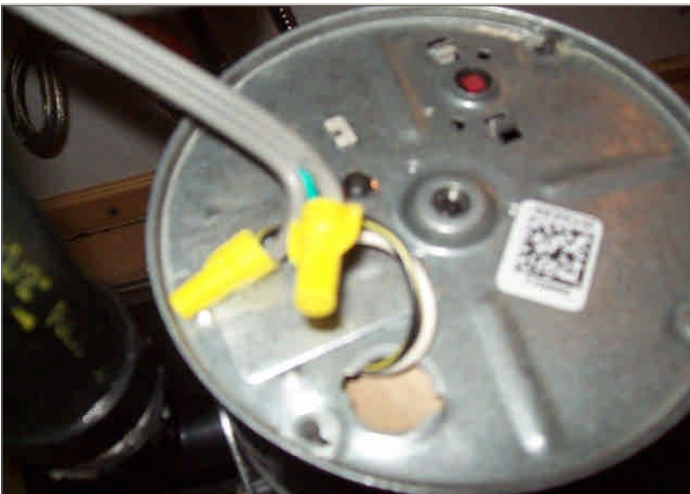
- √ The garbage disposal is incorrectly powered with exposed wires, and should be serviced by an electrician. In law quarters

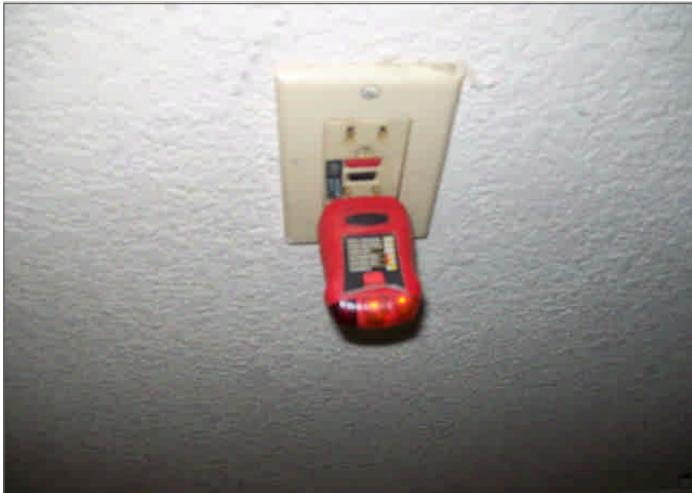
- v The outlets should be upgraded to have ground fault protection, which is mandated by current standards and is an important safety feature. For both laundry rooms
- v A ground-fault protected outlet does not trip on test, and should be serviced. This is in the main house

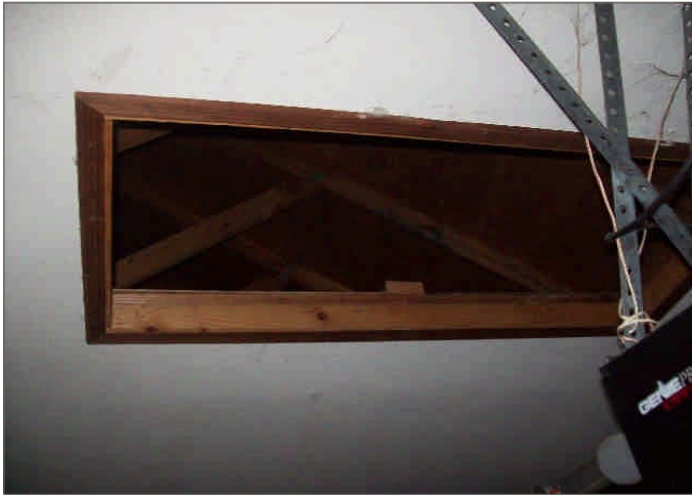
- v The wooden hatch cover to the attic area should be sheathed with metal or drywall, and made to self-close, in order to provide a firewall separation between the garage and the residence.

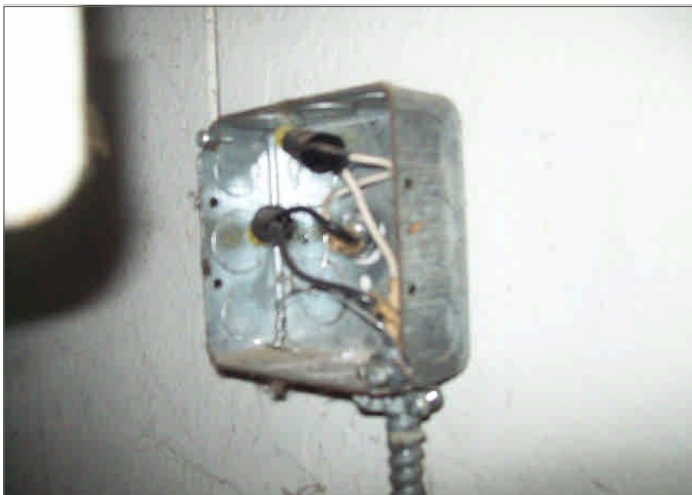
- √ There are open electrical junction boxes, which should be sealed to contain any arcing or sparking that might occur.

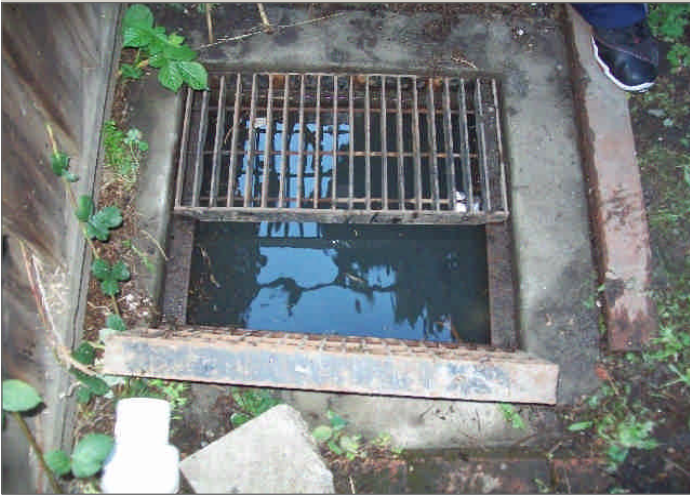
- q There is an accumulation of silt and debris in the catch basins that should be removed. This is indicative of poor maintenance, and if the silt and debris is left to accumulate and builds to the level of the drain lines, it could pass into them, harden during the summer months, impede drainage, and lead to blockages. Therefore, the drain lines should be flushed through to the street or to their termination point.
- q There is standing water or debris visible within the area drains, which is indicative of at least a partial blockage. The tendrils of roots may have invaded the drains, but silt also tends to become trapped within the drain pipes and hardens during the summer months to the consistency of wet concrete and creates an impediment that commonly leads to a full blockage. Therefore, we recommend that the lines be flushed through to the street or to their termination point.

There is standing water or debris visible within the area drains which should be cleared - *Continued*

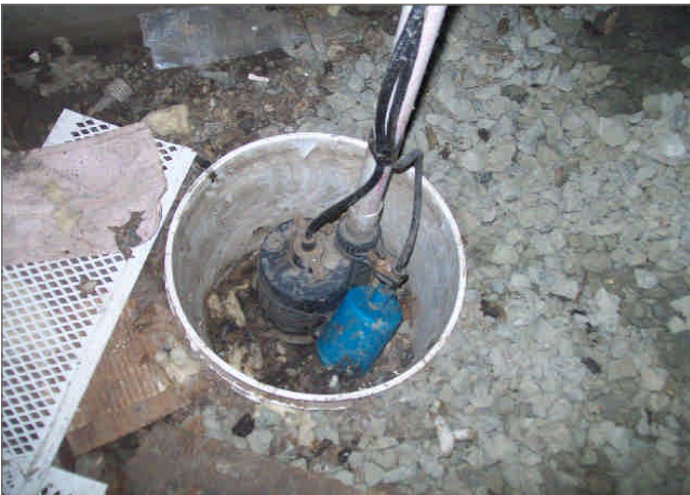
- m The drainage system includes a sump pump, which must be kept clean and monitored periodically or drainage problems could result.

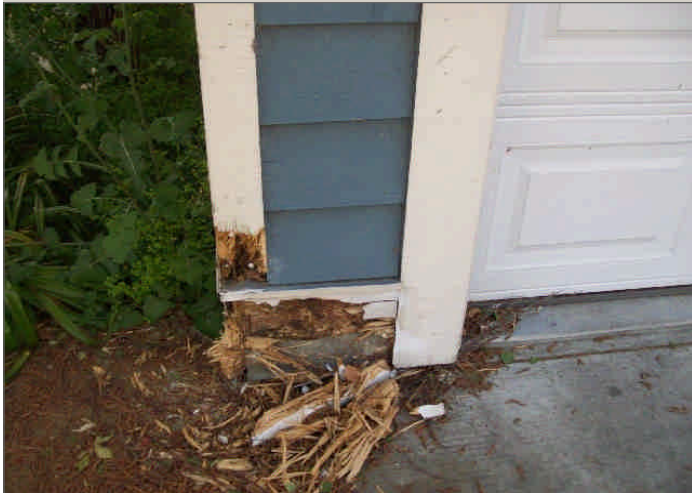
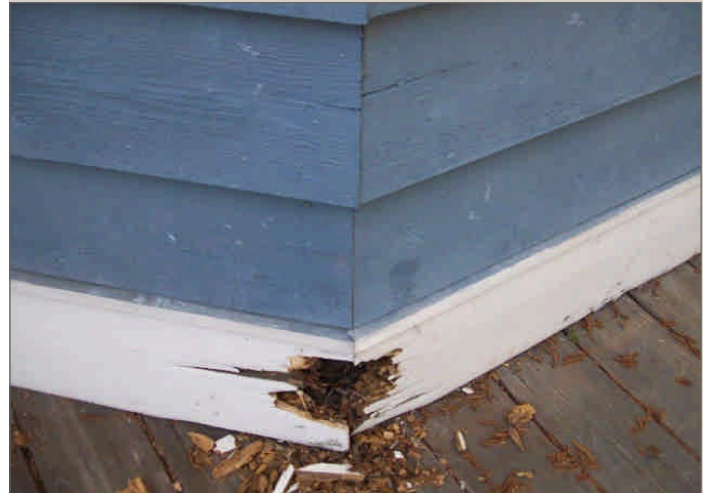
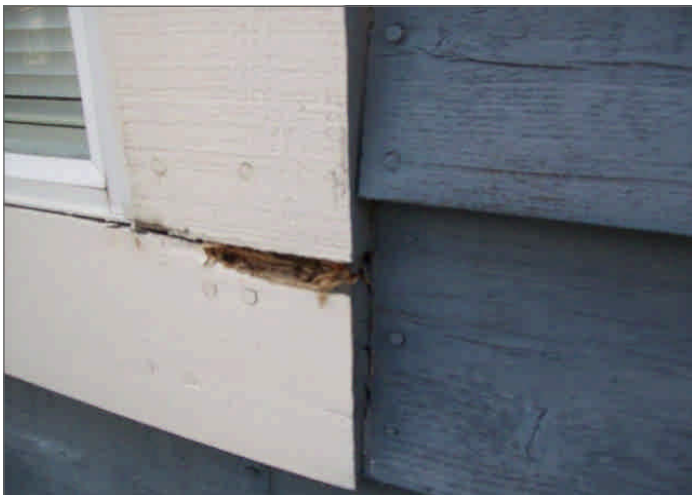
- q Sections of the fascia and trim need maintenance type service. Open joints need to be sealed through out the structures exterior to forestall water intrusion.
- q Sections of the fascia board or wood trim are weathered, and should be serviced to prevent further deterioration.
- q There is damage to the wood trim that should be evaluated by a termite inspector.

There is damage to the wood trim that should be evaluated by a termite inspector - *Continued*

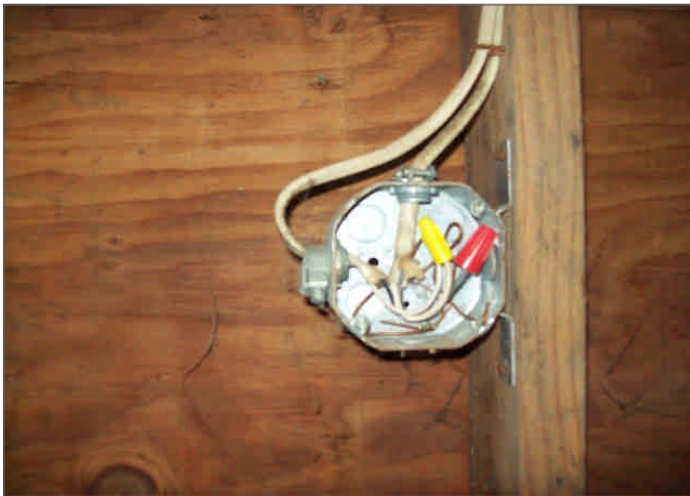
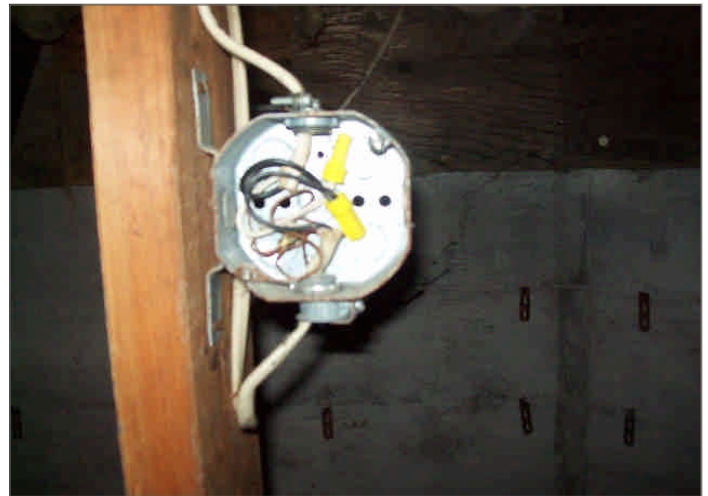
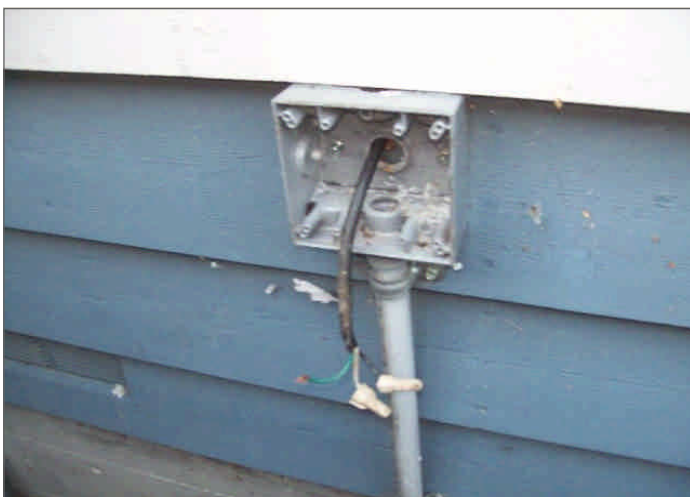
- √ There are open electrical junction boxes, which should be sealed. This is evident under the house and at the side yard

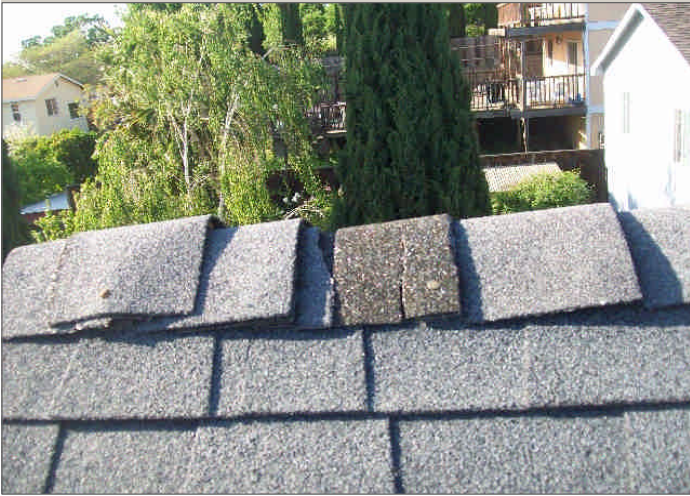
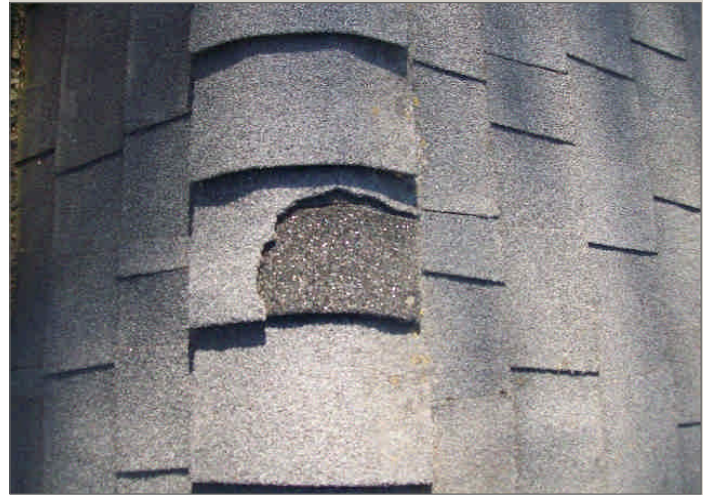
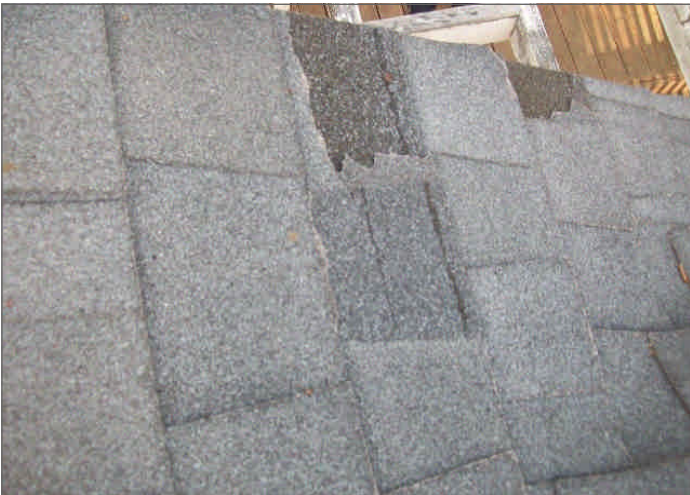
- q There are missing shingles and exposed underlayment and should be evaluated by a roofing contractor, because the cost of replacing the roof could significantly affect your evaluation of the property.
- q There are some missing shingles that need to be replaced

There are some missing shingles that need to be replaced - *Continued*

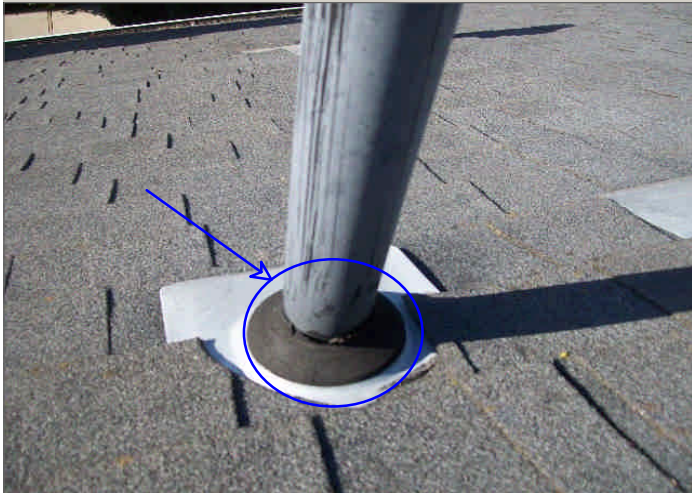
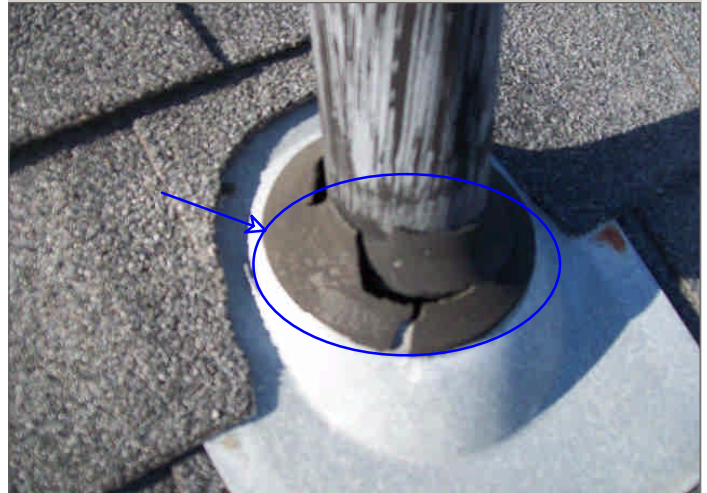
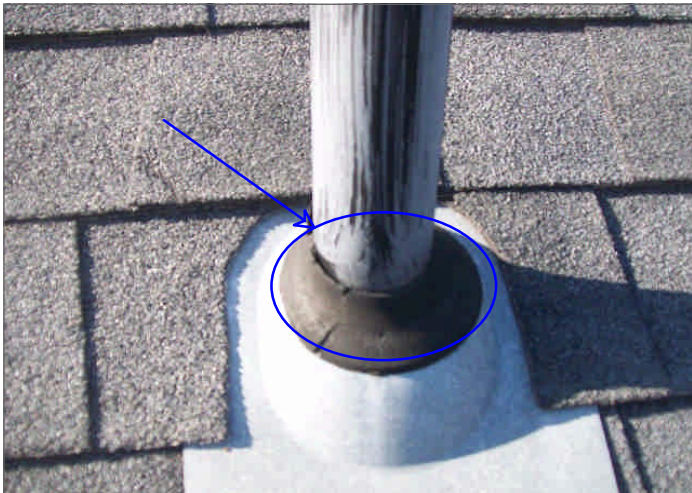
- q The roof flashing's need to be sealed or serviced. They are comprised of metal that seals valleys and vents and other roof penetrations, and are the most common point of leaks. This is particularly true of the flashing's on a layered roof, which are covered by the roofing material and which are even more susceptible to leaks. The rubber boots need to be replaced

The roof flashing's need to be sealed or serviced - *Continued*

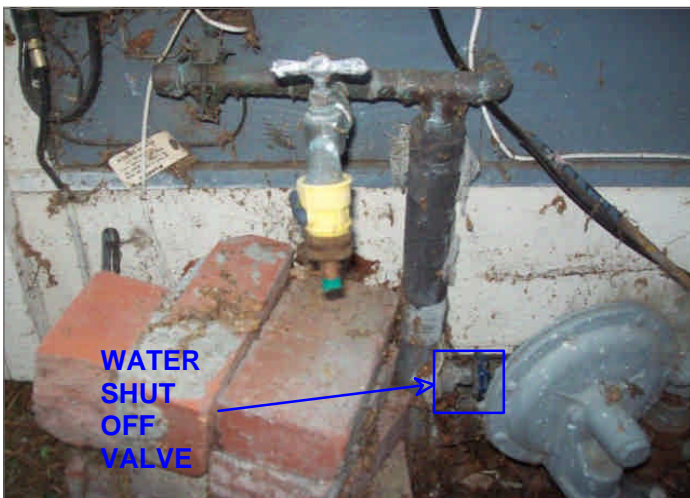
- m The main water shut-off valve is located in the house side yard.

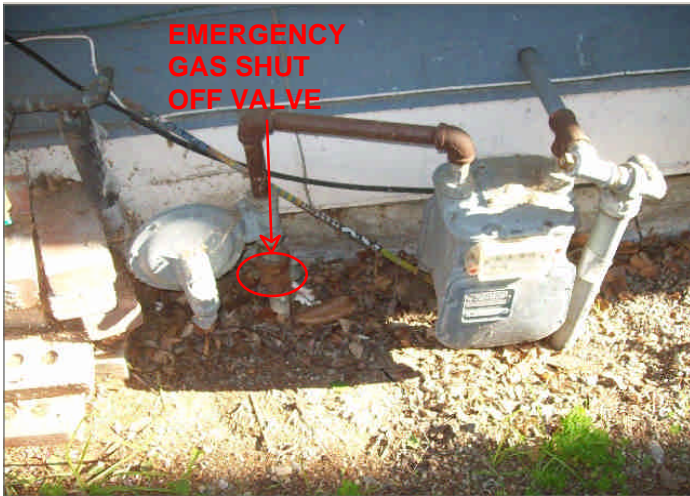
- m The gas main shut-off is located in the garage side yard . You should be aware that gas leaks are not uncommon, particularly underground ones, and that they can be difficult to detect without the use of sophisticated instruments, which is why natural gas is odorized in the manufacturing process. Therefore, we recommend that you request a recent gas bill from the sellers, so that you can establish a norm and thereby be alerted to any potential leak.

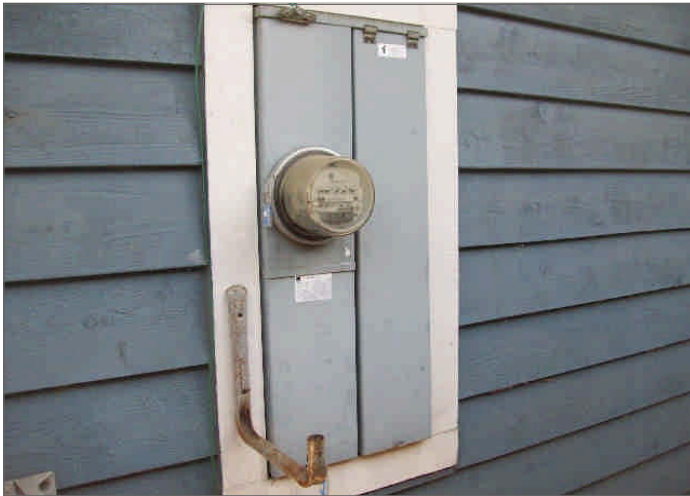
- m The residence is served by a 200 amp, 220 volt panel, located in the garage side yard.

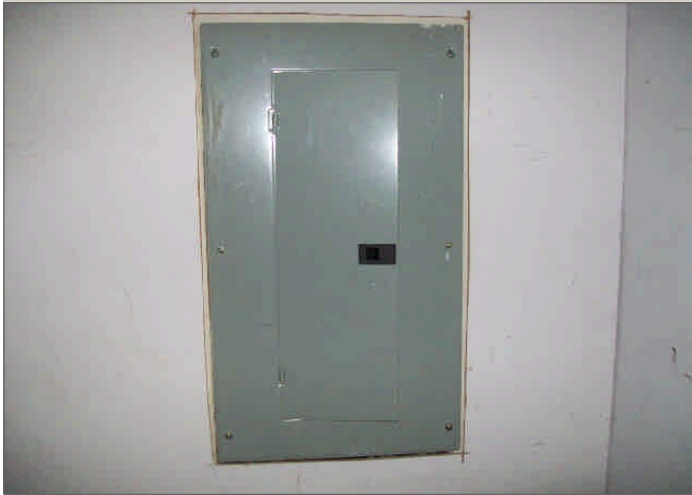
- m The sub panel is located inside the garage in main house

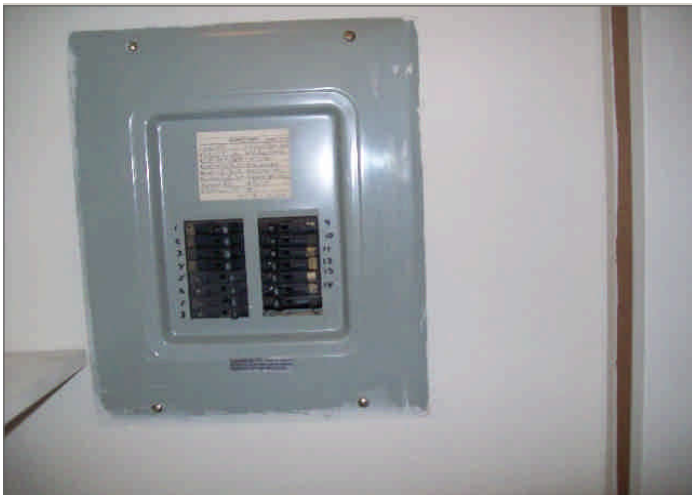
- m The sub panel is located in the laundry room in law quarters

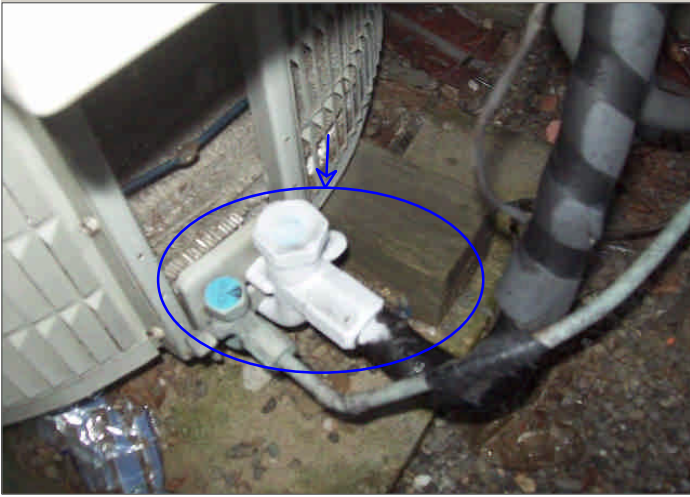
- q Ice forms on the refrigerant lines, which has multiple causes ranging from closed off registers and clogged filters to low refrigerant, and the system should be serviced by an HVAC contractor.

The refrigerant lines are icing which indicates a need for service - *Continued*

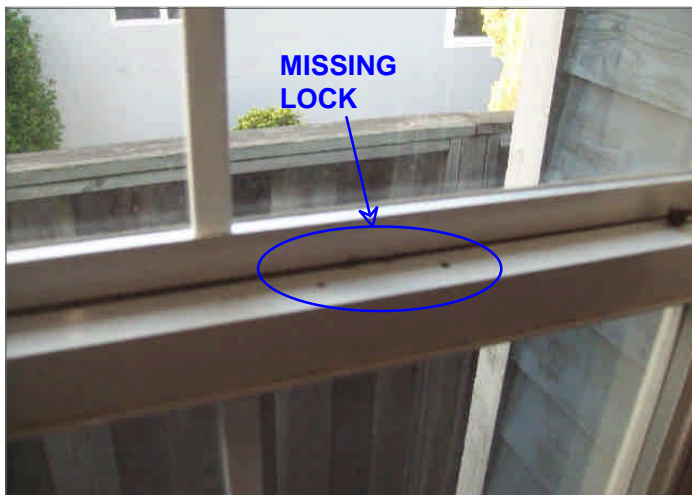
- q A windows lock is missing or does not engage, and should be serviced.

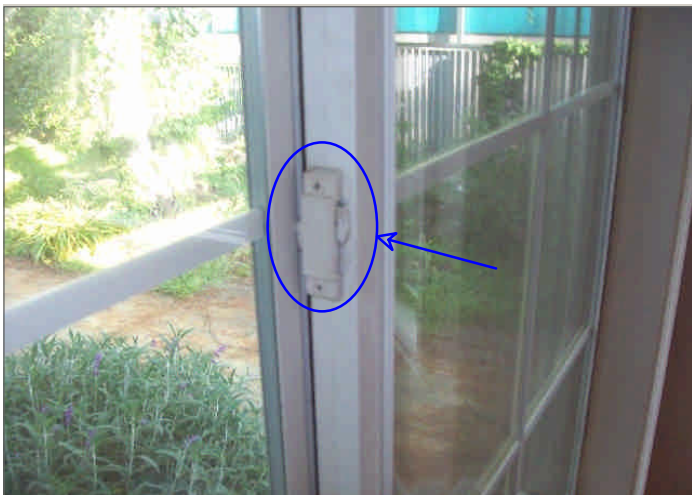
- q A windows lock is missing or does not engage, and should be serviced.

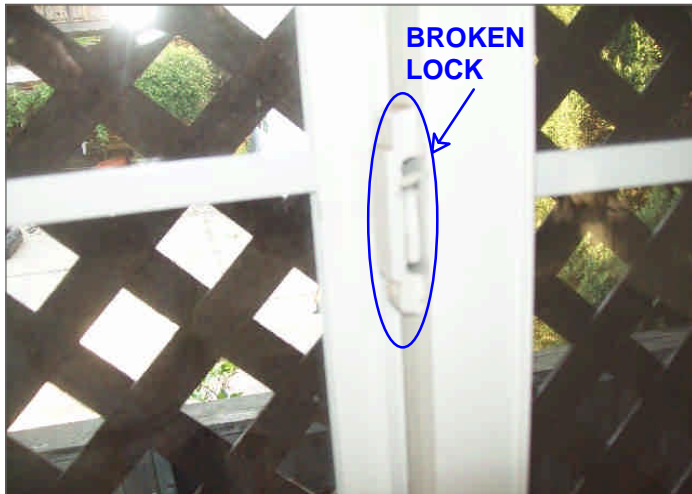
q A window lock is missing, or needs to be serviced, to be functional.

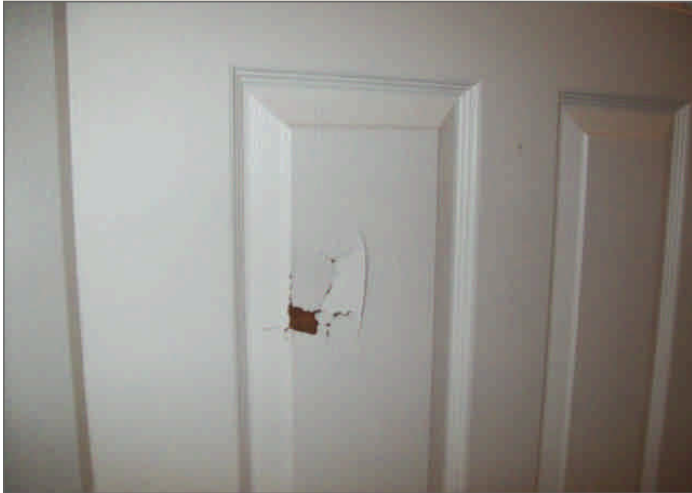
- q The door rubs, and needs to be serviced to work smoothly.
- q The door is damaged and should be repaired or replaced

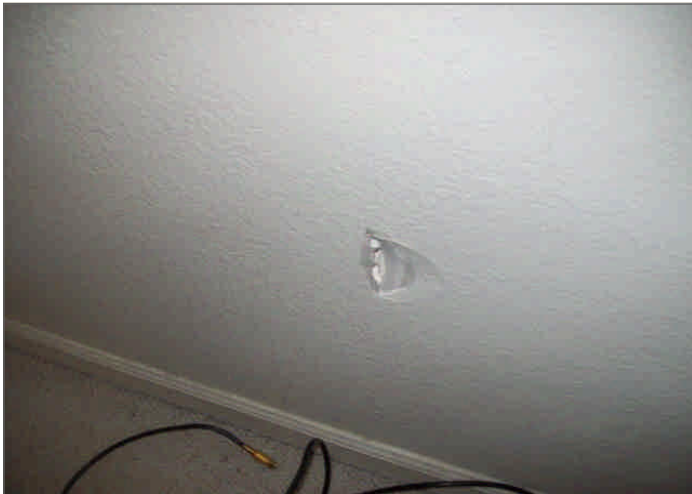
- q The walls have typical cosmetic damage.

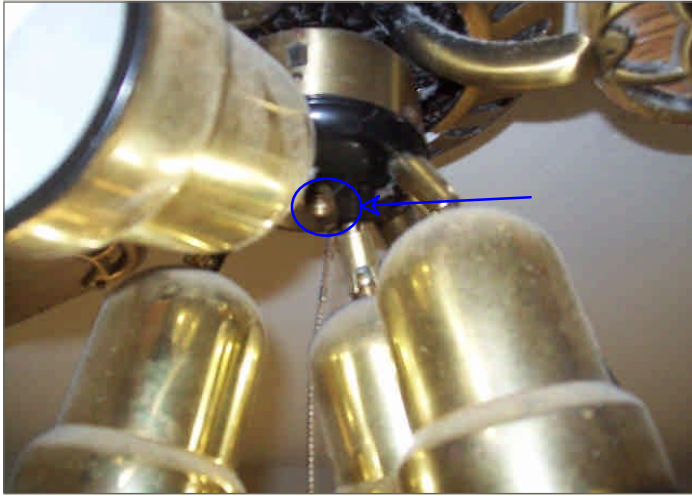
- q The pull chain for the light switch is missing

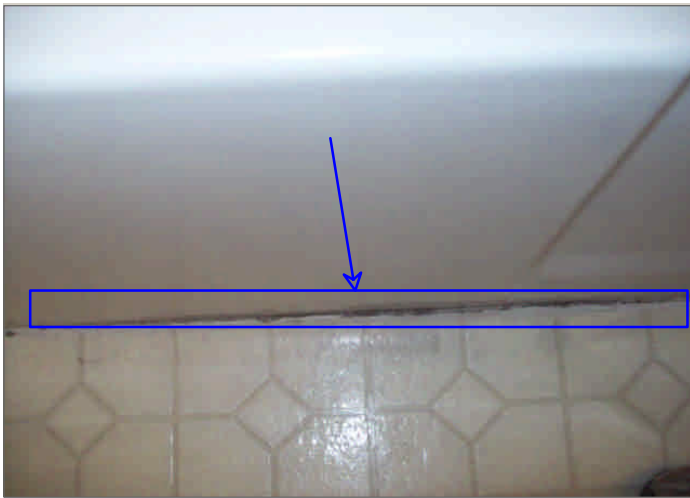
The floor seam next to the bath tub is lifting due to moisture penetration or poor workmanship - *Continued*

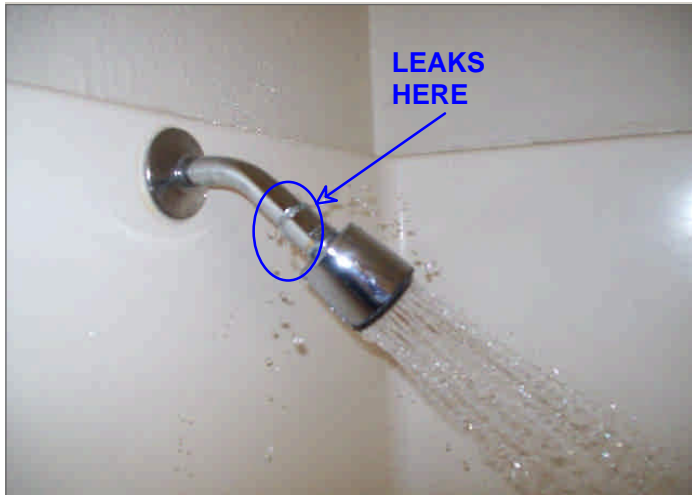
The tub-shower valves leaks - *Continued*

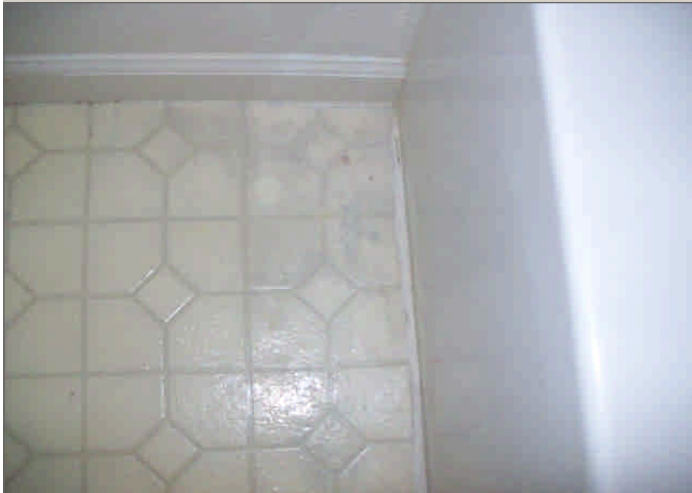
The floor is moisture damaged and should be evaluated by a termite inspector - *Continued*

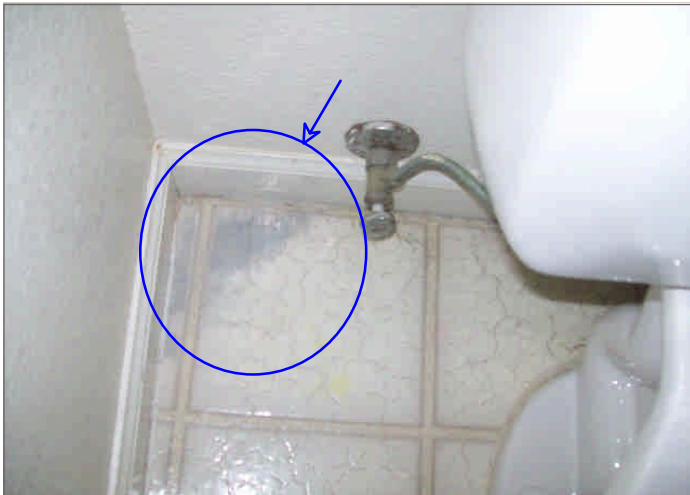
- q The floor is moisture damaged and should be evaluated by a termite inspector.

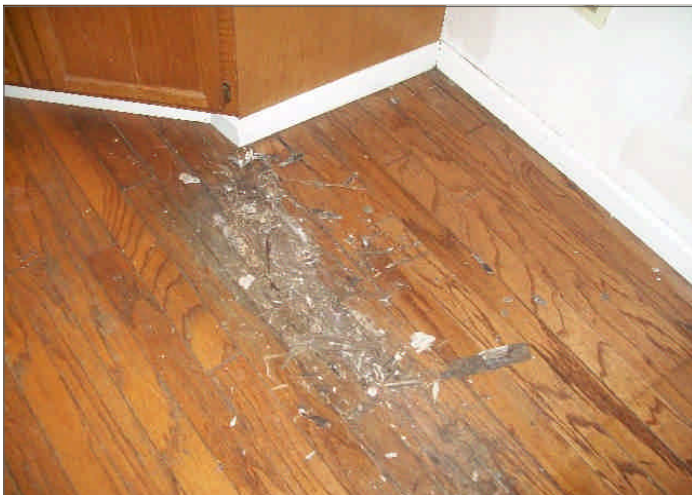
- q The floor is moisture damaged and should be evaluated by a termite inspector. In main house
