Eagle Eye Inspection Services

CONFIDENTIAL INSPECTION REPORT

123 Sample Report Ave , Sample, CA 945

SUMMARY REPORT

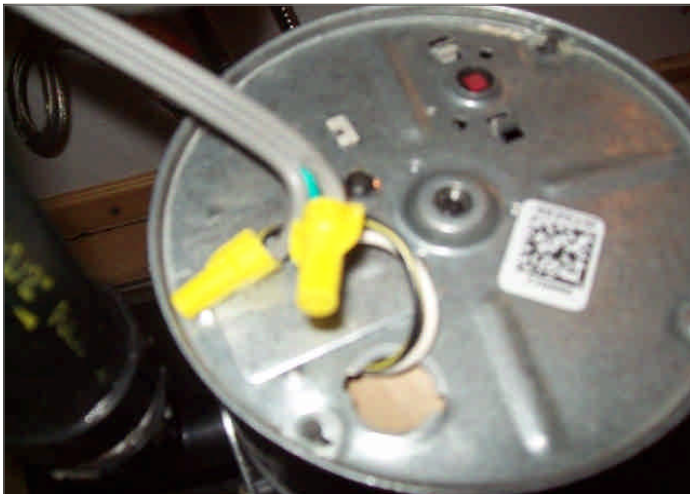
- √ The garbage disposal is incorrectly powered with exposed wires, and should be serviced by an electrician. In law quarters

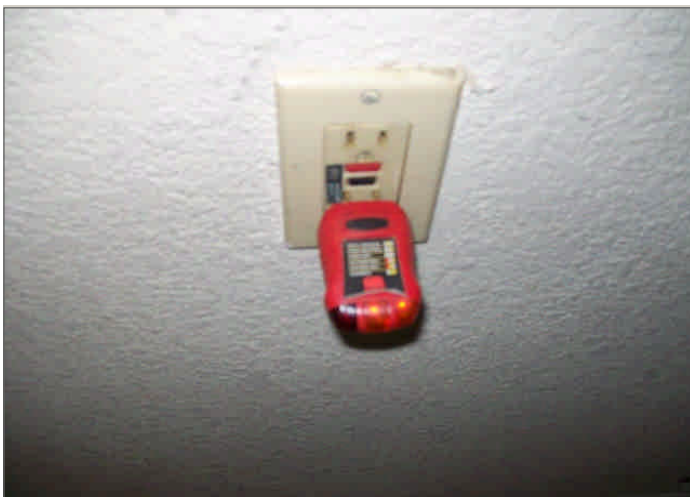
- ✓ The outlets should be upgraded to have ground fault protection, which is mandated by current standards and is an important safety feature. For both laundry rooms
- ✓ A ground-fault protected outlet does not trip on test, and should be serviced. This is in the main house

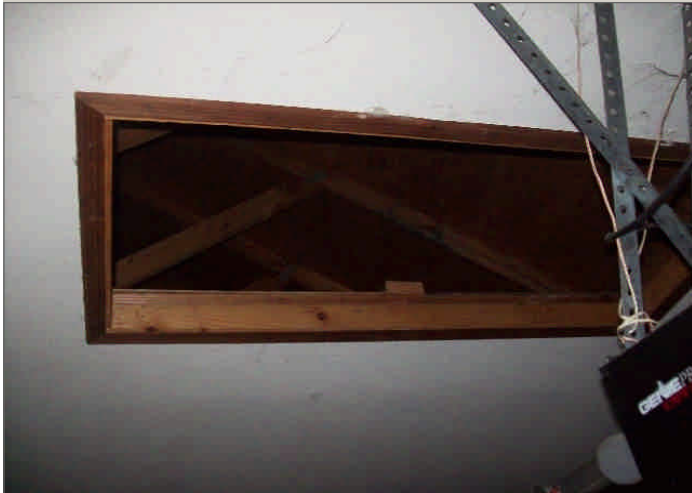
The access cover to the attic area should be sheathed with metal or drywall - *Continued*

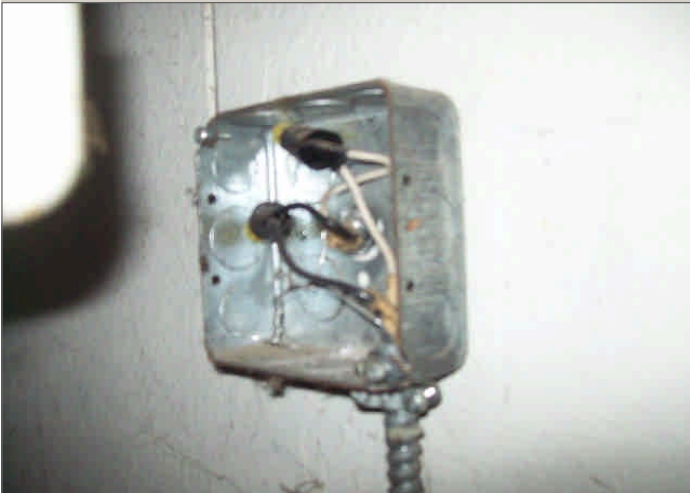
There are open electrical junction boxes which should be sealed - *Continued*
